**STATEMENT OF TOM BRANTLEY
PRESIDENT
PROFESSIONAL AIRWAYS SYSTEMS SPECIALISTS (PASS)
AFL-CIO**

**BEFORE THE HOUSE COMMITTEE ON TRANSPORTATION AND
INFRASTRUCTURE – SUBCOMMITTEE ON AVIATION**

**ON
FAA’S AGING ATC FACILITIES: INVESTIGATING THE NEED TO
IMPROVE FACILITIES AND WORKER CONDITIONS**

JULY 24, 2007

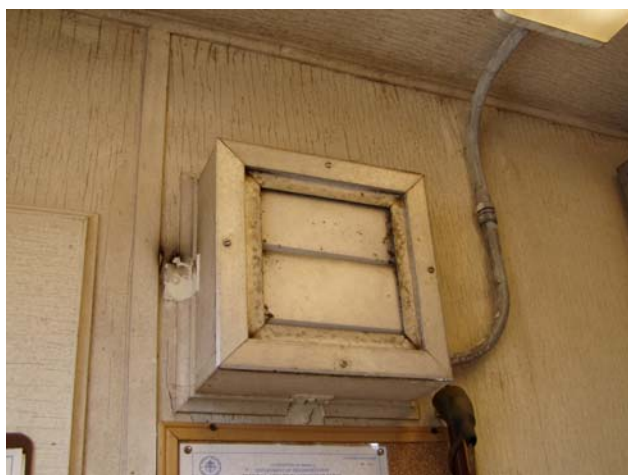
Picture A
Non-Directional Beacon Facility, Rutland, Vt.

Disturbing examples of exposure to mold and asbestos can be found at numerous facilities nationwide. It cannot be overstated that in many situations, the harmful conditions have existed for years without the FAA addressing the problems. Employees working at the non-directional beacon facility in Rutland, Vt., are being exposed to dangerous inhalants on a daily basis (see Pictures A and B). Asbestos tiles are cracked and broken and there is black mold on the walls of the facility, creating a serious health hazard for personnel. The asbestos problem was originally identified in 2004 and has yet to be addressed; nonetheless, this facility is still fully commissioned and FAA employees are performing regular maintenance within this building. Other examples of the FAA’s disregard of these problems include asbestos being detected at the Remote Communications Air to Ground site in Garden City, Kan., for over five years without any effort being made to replace the flooring; and mold being a problem at the Houston Hobby Very High Frequency Omnidirectional Range (VOR) in Texas for over seven years.

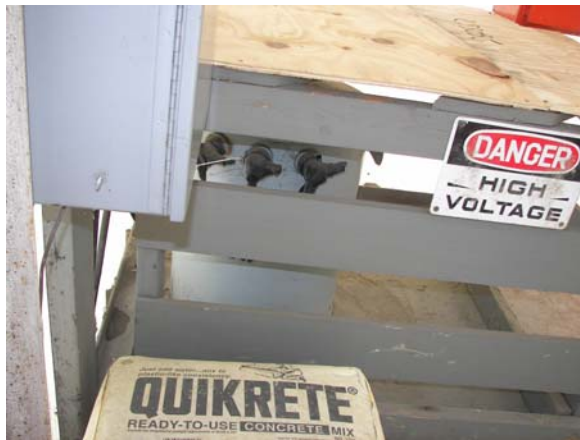
Picture C: Runway End Identifier Lights, Allegheny Airport in Allegheny County, Penn.

In other examples, improper or unstable housing of high-voltage equipment poses a threat to employees required to work with such dangerous equipment. It should be expected that this FAA equipment would be given the utmost attention in terms of being properly housed in order to avoid endangering the employees working on the equipment and ensure that the equipment works properly. In many FAA facilities, however, this is not the case. The building housing Runway End Identifier Lights, which provide rapid and positive identification of the approach end of a particular runway, at the Allegheny Airport in Allegheny County, Penn., includes several high-voltage transformers. Requirements for high-voltage transformers dictate that they should be enclosed in metal enclosures. One transformer located outside the building at the facility is inside a chain link enclosure. Inside the building, however, is a second transformer with only some wood railing around it and a loose plywood cover (see Picture C). Placing a high-voltage transformer in a wooden container with an inadequate cover is in direct violation of the requirements for housing such equipment. Even more disturbing is that this has been the situation at the facility for decades despite an annual requirement for safety inspections.

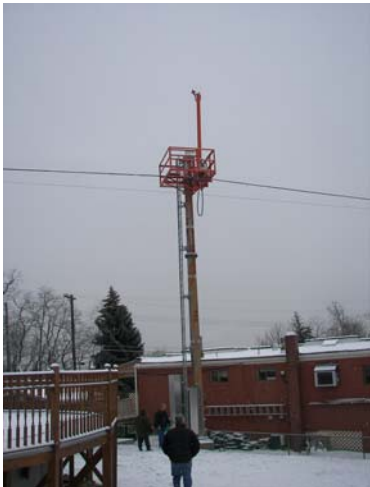
Picture D

- The tower for the MALSR at Allegheny Airport is in critically unstable condition, threatening the safety of employees as well as private citizens who reside near the tower. Employees working on the MALSR tower have reported that the base shifts when they are working on it. Local FAA management told a PASS safety representative that they were aware of the cracks, but that the tower had been deemed stable in an engineering report. However, management would not provide the PASS safety representative with a copy of the report. An employee was witnessed climbing the tower and, as soon as he moved around on the platform at the top, he was ordered back down because the steel base of the tower shifted on the concrete foundation and even lifted slightly in one corner, an indication that the bolt was pulling free from the concrete (see Picture D). This is not only an obvious threat to FAA employees, but the nearby residence is at risk of being destroyed if this tower fell down (see Picture E). Management has since labeled the tower as off limits for employees. Furthermore, the entire lighting array is wired together so if this tower goes down in a storm, the whole lighting system for the runway will go out.

Medium Intensity Approach Lighting System and Runway Alignment Indicator Lights (MALSR), Allegheny Airport in Allegheny County, Penn.

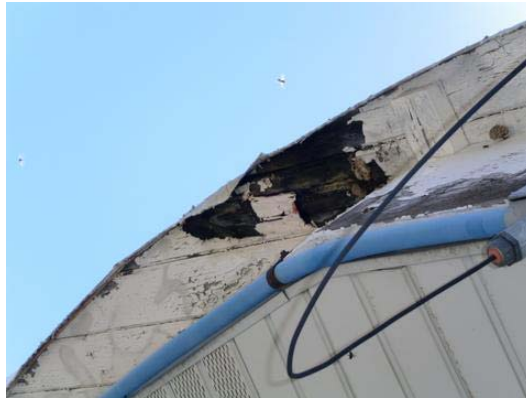
Picture F: VOR Facility, Litchfield, Mich.

- The VOR facility in Litchfield, Mich., is deteriorating and in desperate need of repair or replacement. The building is in a severe state of general disrepair, the door is rusted and not sealing correctly, and the antenna platform is physically rotting away (see Picture F). The VOR is a type of radio navigation system for aircraft, and the stability of the VOR and its antennas is crucial for the proper operation of this facility.

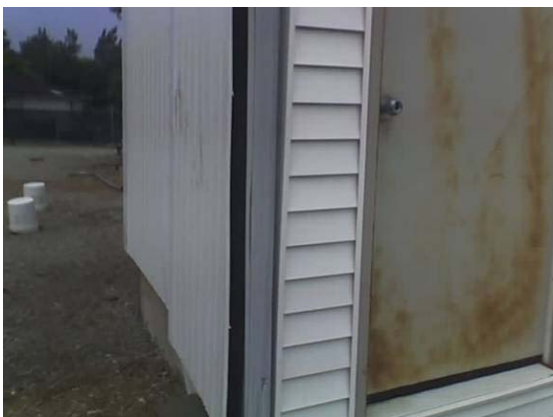
Picture G
Radar Communications Building, Chicago Midway Radar Facility, Indiana.

- The radar communications building for the environmental support unit for the Chicago Midway radar facility, which also acts as a backup to Chicago O'Hare International Airport, is in terrible condition, including rusting doors, peeling siding and general disrepair (see Picture G). There is also water damage from a leaky roof on the building that houses the communication equipment less than 15 feet away. A gap under the doorway leading into the building allows water and rodents/insects to enter the building (see Picture H). Additionally, the exposure to outside conditions causes temperature to vary greatly within the building due to escaping heat or air conditioning, which in turn can affect NAS equipment performance.

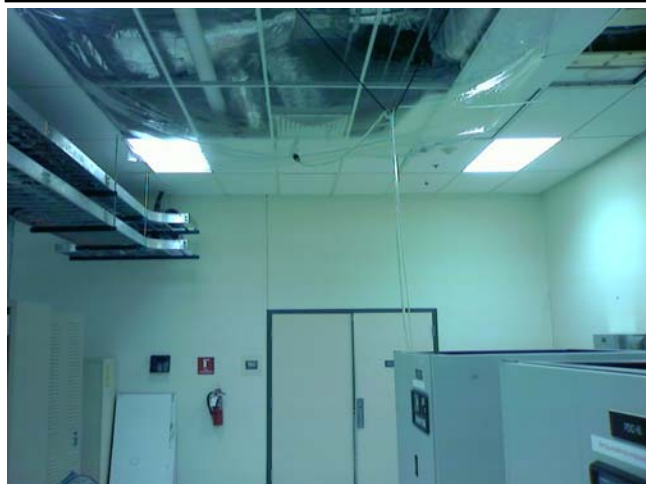
Picture I: Denver TRACON

- A leaking roof at the Denver Terminal Radar Approach Control (TRACON) facility is putting the important aviation equipment within the building at risk of being damaged. A makeshift “leak catcher” has been installed at the facility instead of fixing the problem (see Picture I). The leak catcher runs from the ceiling into a bucket on the floor. The tubes are mere inches from the air handler, power cables and outlets. This has been the condition at this facility for over a year.

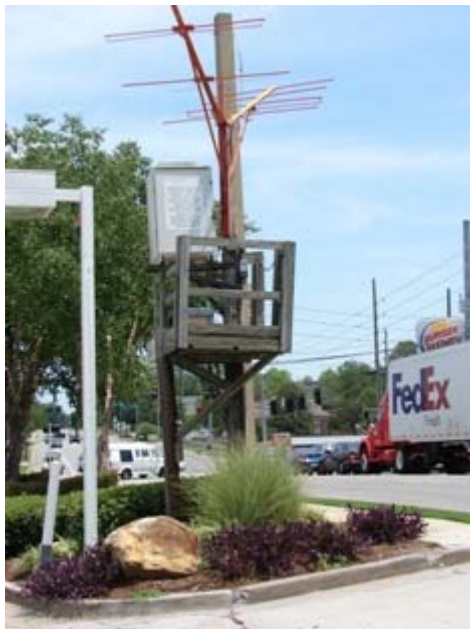
Picture J: Outer Marker, Peachtree Dekalb Airport

- The Outer Marker at the Peachtree Dekalb Airport in Georgia sits in an unsecured location beside a gas station at a busy four-way intersection (see Picture J). Although a technician has informed the FAA that the platform is unstable and too small to conduct maintenance activities, no corrective action has been taken for over two years.
